# WILDCAT ROCK TRAIL

in 2024 Hurricane Helene damaged the Wildcat Rock Trail, which accesses the rock and ice climbing area at Little Bearwallow Falls. A landslide destroyed roughly 100 feet of trail tread, located under a historically used ice climbing area. Conserving Carolina hired our C4 Team to do a major restoration, improving the trail's resiliency.

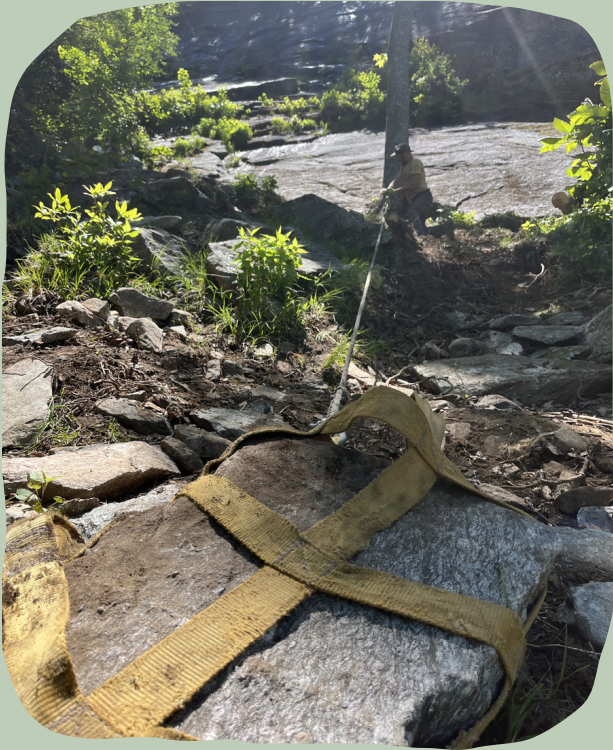
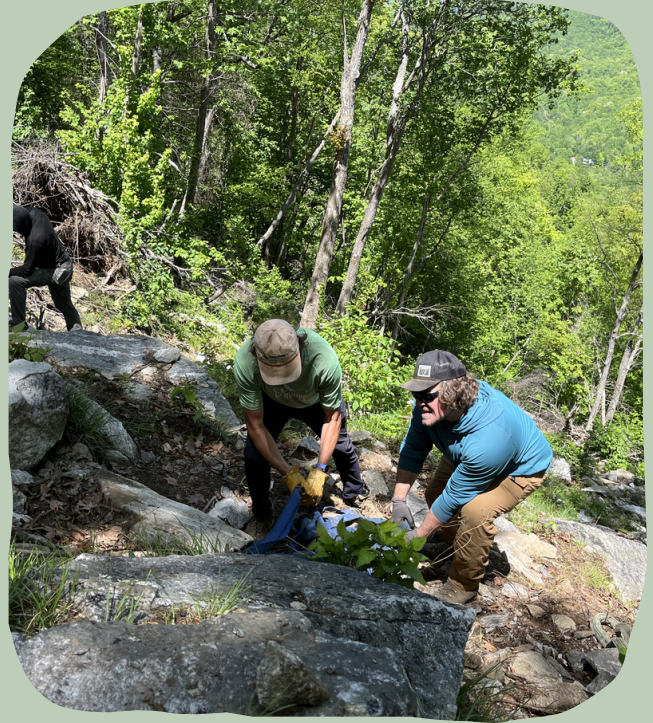
All the rock we used was downhill of the work site, so we had to use rigging techniques to move it up

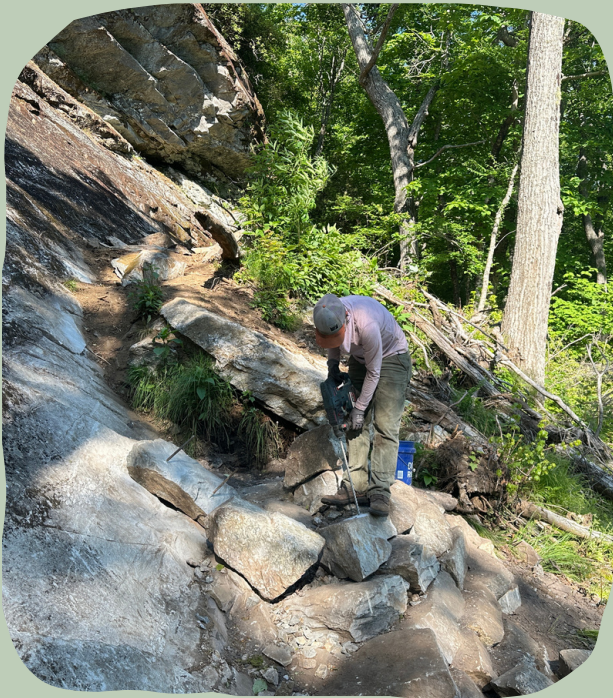
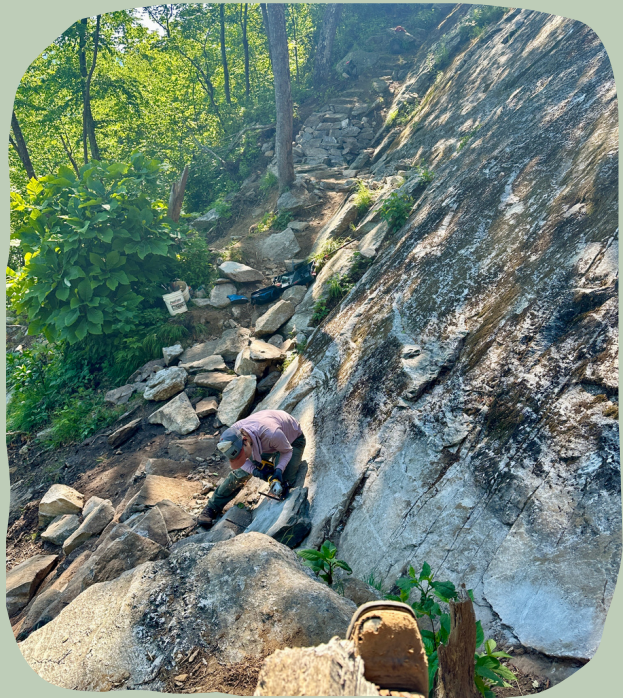
We drilled rocks to split them to the correct size, and used set rebar strategically to stabilize our structures.

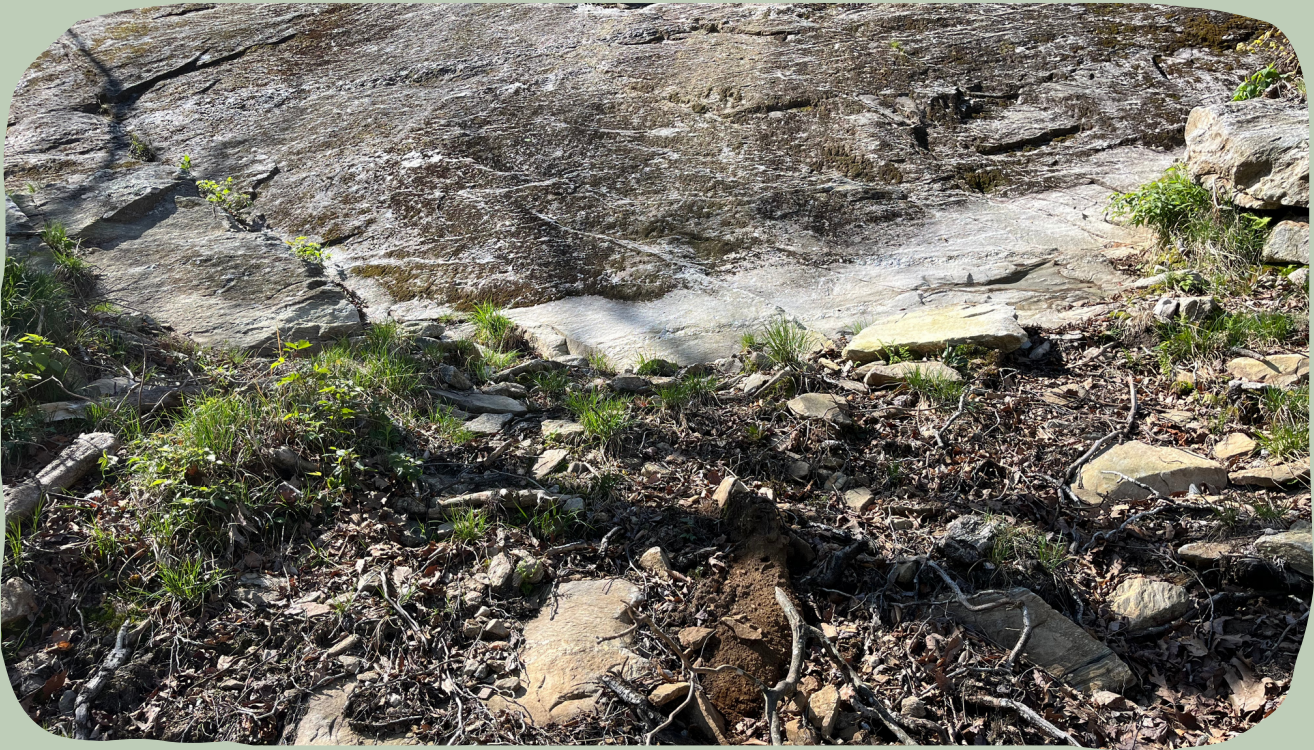
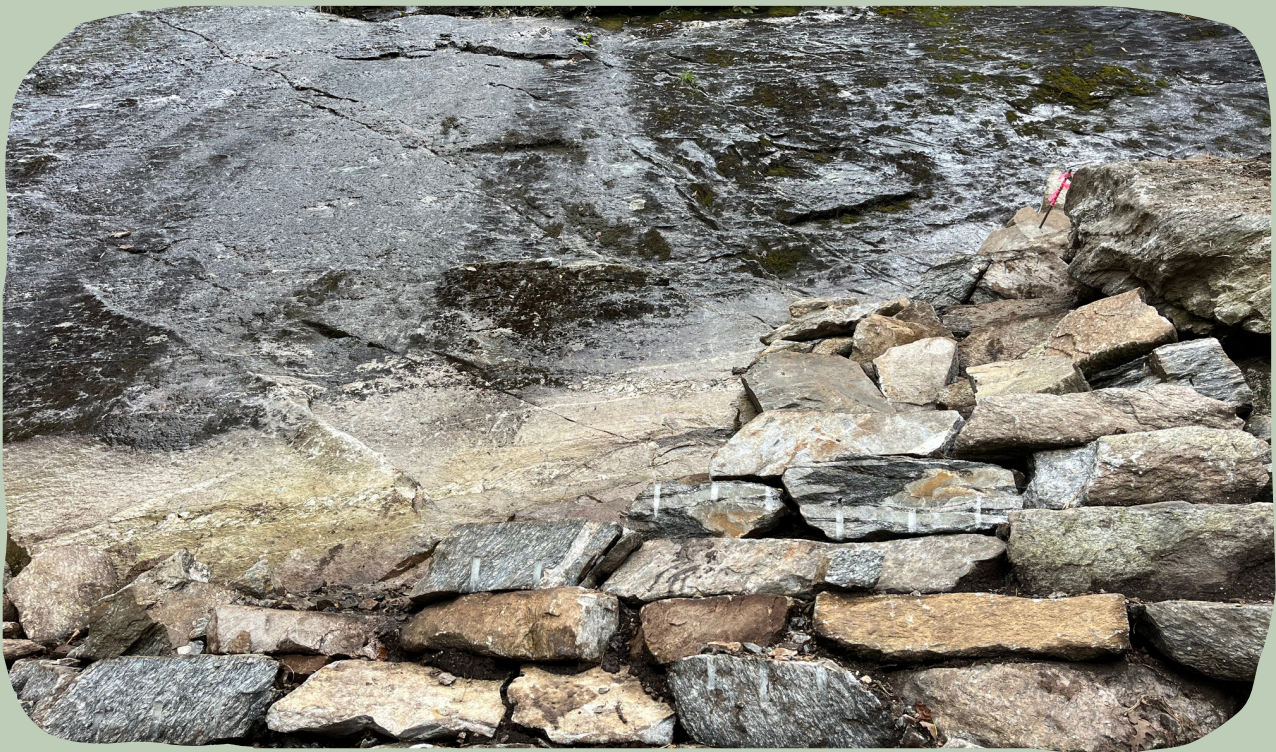
Retaining wall side view of the west steps

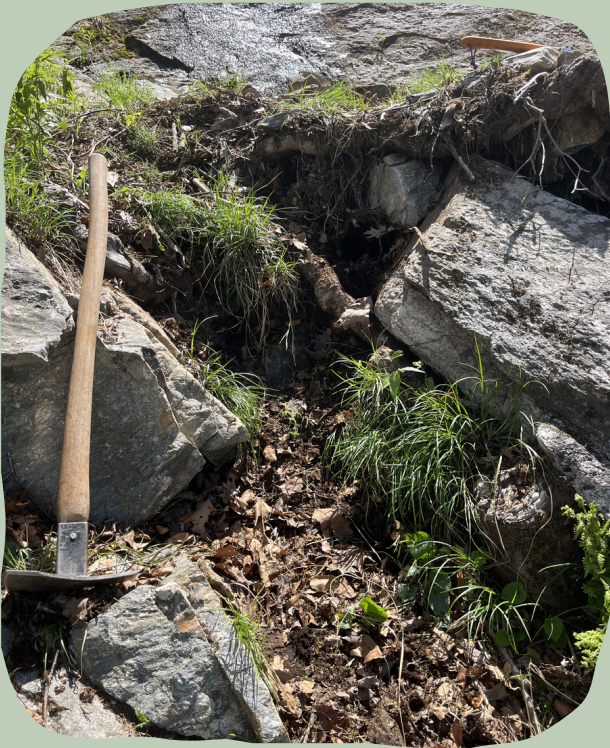
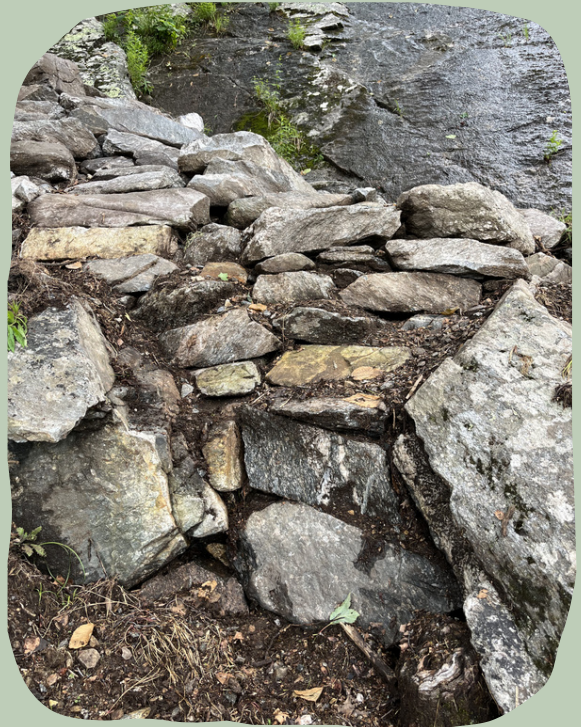
Retaining wall side view of east steps

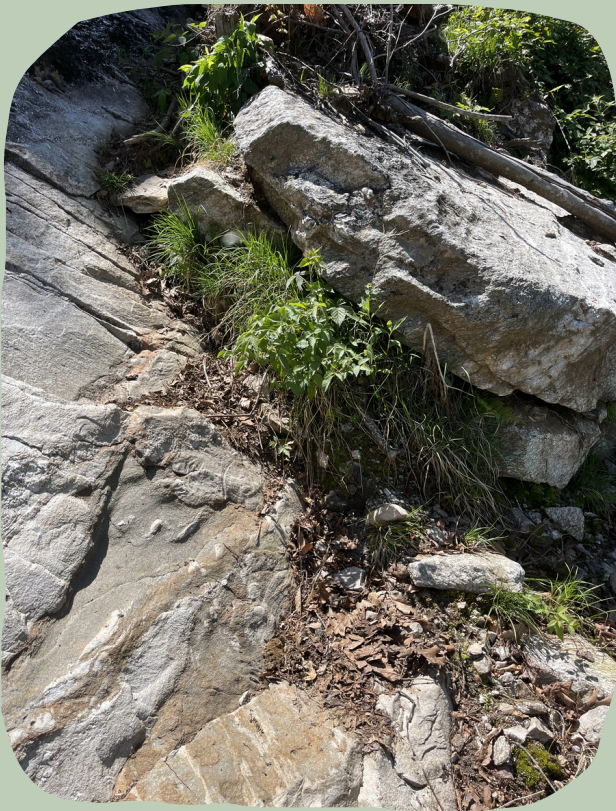
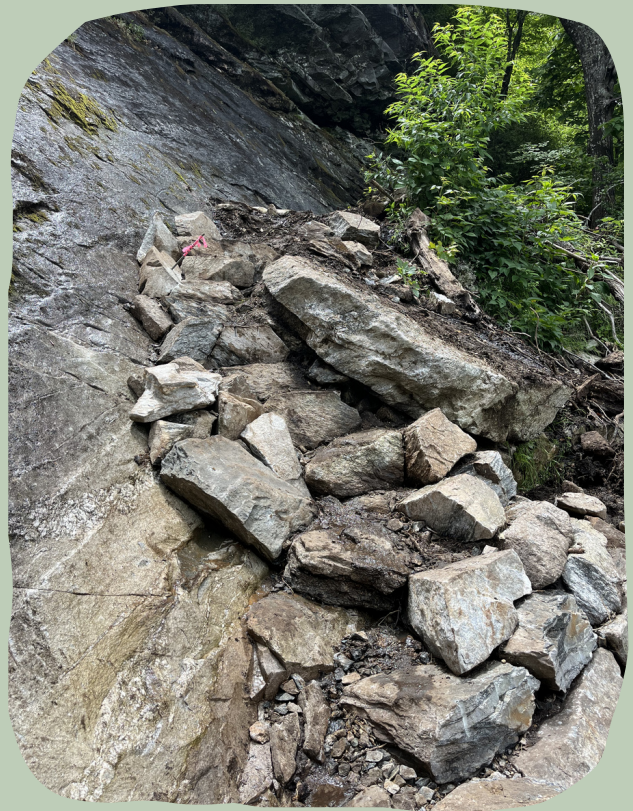
Hiker's view of the west steps

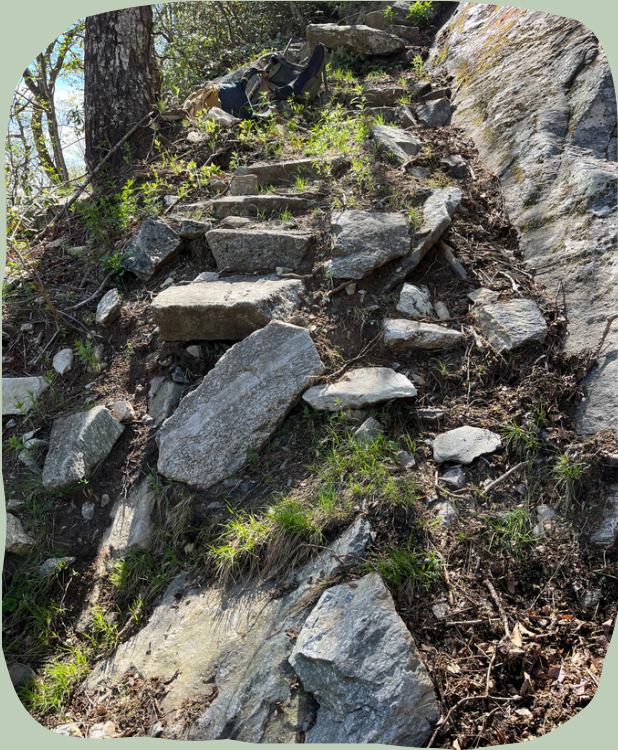
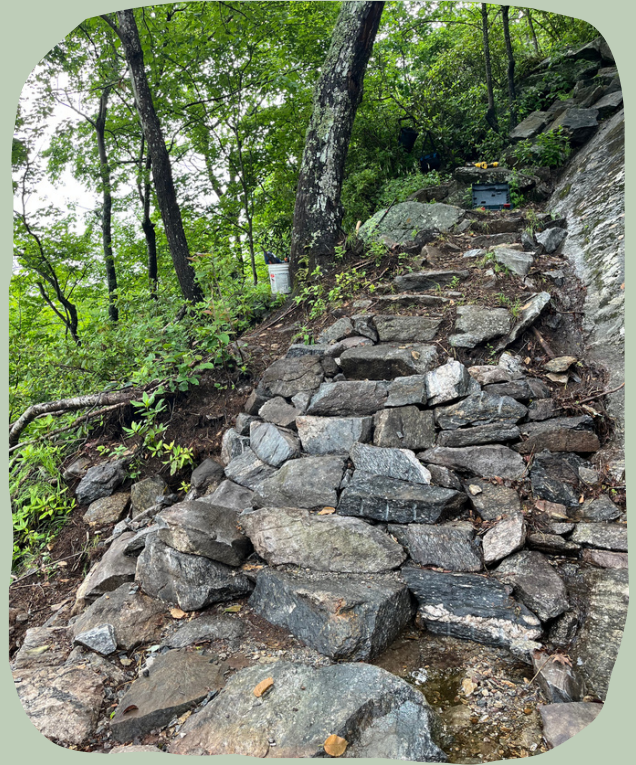
Hiker's view of the east steps
